# Naval Training Cente Orlando, Florida

# Proposed Interim Remedial Action Study Area 35

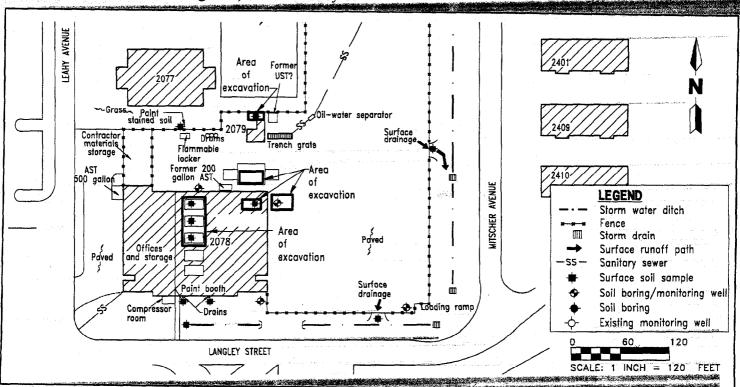
Figure 2. Study Area 35 Site Plan.

Study Area (SA) 35 is located in the central part of the NTC, Orlando Main Base, north of Langley Street between Mitscher and Leahy Avenues (Figure 1). Most of the site is a large paved parking area fringed with grassy swales and lawn (Figure 2). Two buildings, 2078 and 2079, are included in the SA. Building 2078 is a former aircraft hangar used since 1968 for vehicle maintenance. There were eight hydraulic lifts used for vehicle repair, seven inside the building and one outside of the building. The outside lift and six of the inside lifts were constructed in long narrow pits approximately 8 feet deep. Building 2079 was used to store tires, batteries, and hazardous materials.

One of the exterior sample locations was located to the north of Building 2079, adjacent to a door in the north side of the building, where waste material may have been dumped. The other location was at the northeast corner of Building 2078, adjacent to a garage bay in the east side of the building. Additionally, the exterior lift pit north of Building 2078 has evidence of release of petroleum products, based on the oily sheen on the water in the pit. No contamination was detected in groundwater

Two areas outside of Building 2078 will require excavation of surface soil to a depth of two feet: an 8-foot-by-10-foot area will be excavated north of Building 2079, and a 10-foot-by-10-

foot area will be excavated at the northeast corner of Building 2078. Three excavations will be required to remove the soil from the lift pit areas: two of the excavations will be approximately 30 feet by 17 feet by 10 feet deep and the third will be approximately 30 feet by 50 feet by 10 feet deep. The excavations will first require removal of overlying clean soil, then excavation of the TRPH-contaminated soil.
